# Manhole Inspection Summary

Manhole # S11O\_\_018MH

**Location** Address: **3208 Frederick**

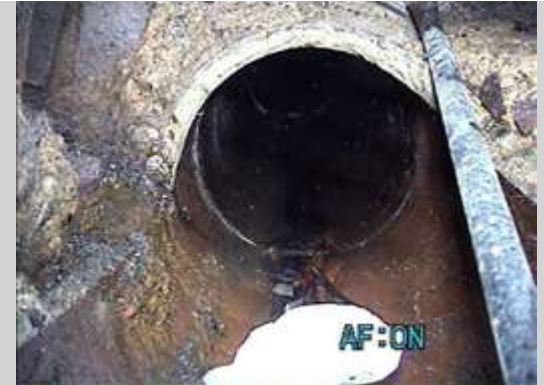
12 O'Clock Outflow

8 in. Circular Gravity Sewer  
Pipe Out @ 12 O'Clock

Pipe Height: **7.2** (in.) Rod and Bar (Angled)  
Pipe Material: **Clay** ☐ Pipe Lined  
Invert Depth: **8.24** (ft.) Flow Characteristics: **Fast**  
Deposits: ☒ None ☐ Mud ☐ Sludge ☐ Debris ☐ Grease  
Silt Depth: **0** (in.) Deposits Extent:  
Infiltration: **None** Pipe Seal Cond: **Unknown**
